NASA/CR—2010-216110

High Pressure Electrolyzer System Evaluation

Kevin Prokopius and Anthony Colozza
Analex Corporation, Cleveland, Ohio

February 2010

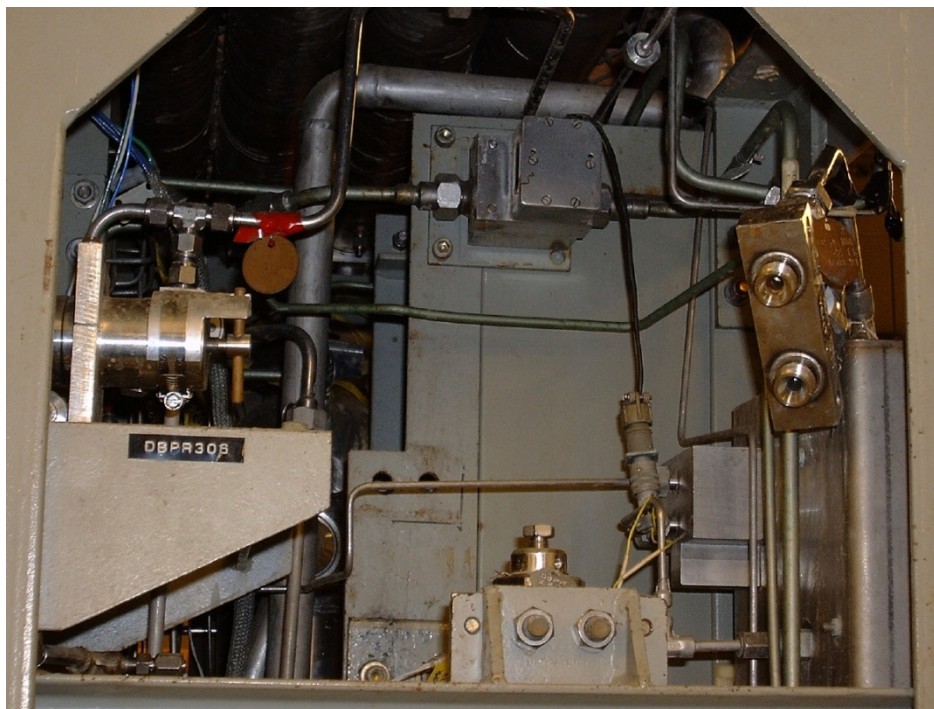
Figure 5.—Disconnected internal components.

The above figures show an example of the state of the system's mechanical and electrical components. Although some components may be salvageable, it is recommended that the system be completely rebuilt utilizing the electrolyzer stack and containment vessel. The containment vessel was sealed off from the fluid lines and therefore should be contaminant free and based on the results of the pressure testing the stack should be in good operational condition. Table 2 gives a summary of the estimated replacement cost for most of the major system components.
